# Museum News: The Duchess of Hackberry

by CW (Bill) Smith, Curator  
Terrell County Memorial Museum

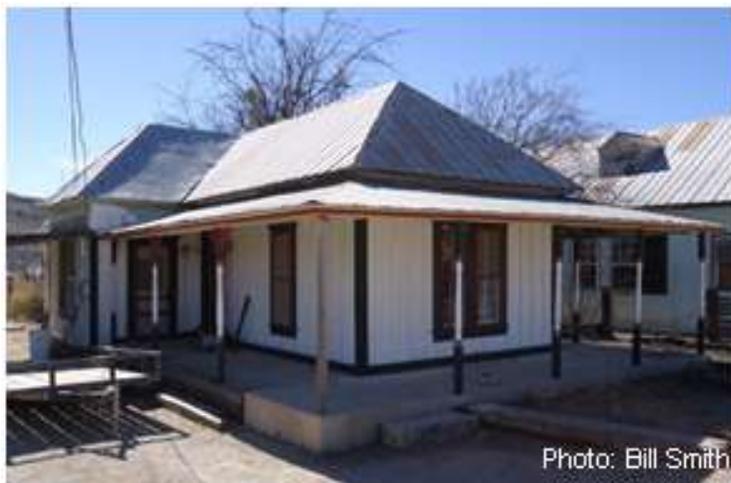
*The Duchess of Hackberry, one of Sanderson's oldest railroad houses still in existence. The rear addition was made after 1920.*

Even though the house shows up in our 1903 photo of Sanderson, its construction details hint at a much earlier origin. It was built in a style my carpenter grandfather called "box house" construction. Appearing in the 1870s, box houses were simple, cheap and easy to construct. They were favored in West Texas, and indeed, most of the West, because of our mild climate and the scarcity of lumber.

So, our little house on Hackberry sits like an aging dowager, a little frumpy with her porch railings and most of her gingerbread gone, but with her heritage and dignity intact. With proper care and addition of a little makeup and jewelry by her new owners, she could become the duchess of Hackberry.

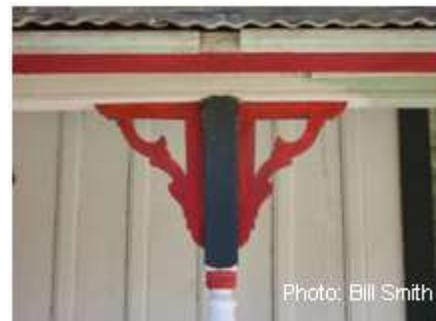
*Porch column bracket, the only gingerbread detail left on the house.*

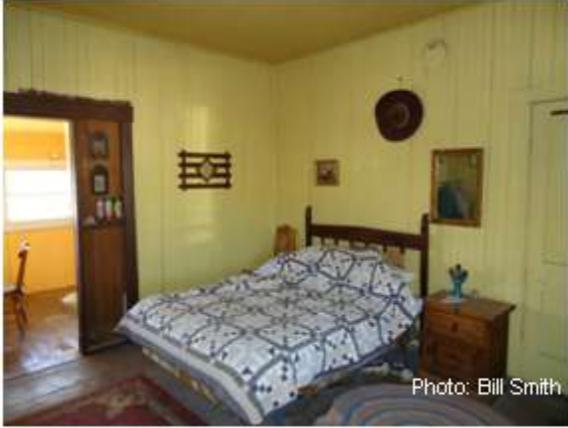
*Interior detail showing the beaded-board walls.*

One-by-ten or one-by-twelve boards were nailed upright to the floor platform and the plate at the top to cover the wall. This was full dimension lumber, not the under-sized, crooked stuff we get now! Thin batten strips were nailed over each upright joint to bind the wall together and seal out the weather. This created a very flimsy wall that still allowed our famous West Texas dust, cold air and even rain to come through. With the addition of 3/8" thick by 4" wide beaded-board to the interior, no one would have known that the walls were less than an inch thick!

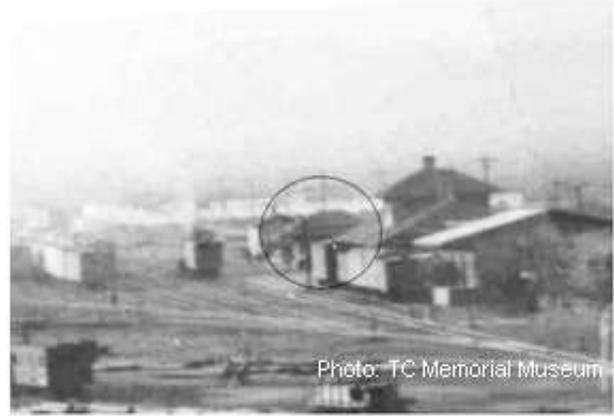
*Earliest photo of the depot area, ca 1903. Our house is circled.*

At last I spotted the house in our earliest town photo, taken about 1903 from a low point on the mountain just south and east of town, aimed to the northwest toward the Harrell Dairy and the depot. Knowing now where to look, I found a photo taken around 1915 to the west of the depot, looking back east, and there she was, in all her glory, unmistakably the house in question. It had turned porch columns with cross buck-style porch railings, and even a hint of the Victorian gingerbread was evident. Much of that decoration was gone now, but it was the house.

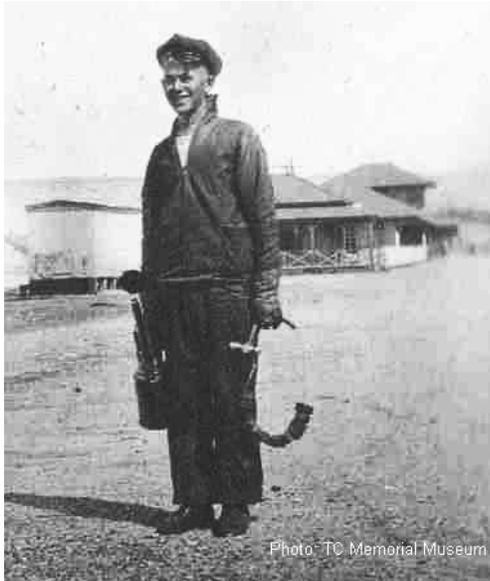
*W. H. Lemons, Jr., railroad car knocker, with our house in the background, showing cross buck-style porch railings. Ca 1915*

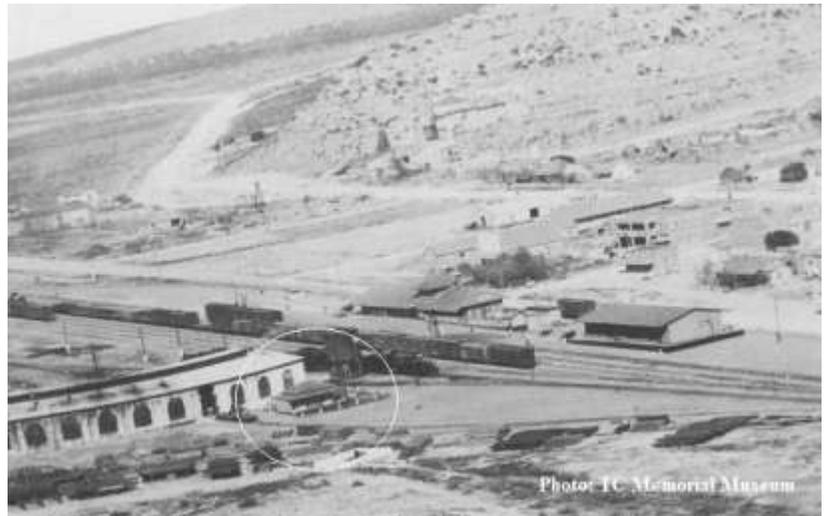
*Depot area, ca 1920. Our house is now moved to the north end of the roundhouse, where it sat for the next forty years. Probably the roundhouse foreman's home, someone has taken time to landscape with addition of a lawn and white fence posts.*

Going to a panoramic bird's-eye view of Sanderson, taken about 1920, she jumped out at me again, but not where she had been before. Now she had been moved to the east, adjacent to and east of the north end of the roundhouse.
